Rehabilitation of Existing Seawall in Fujairah to Withstand Cyclone Conditions

Ashoor, Arash;^{1*}; Trindade, Jorge²

1- Senior Coastal Engineer, Sogreah Gulf, Artelia Group, Dubai, United Arab Emirates

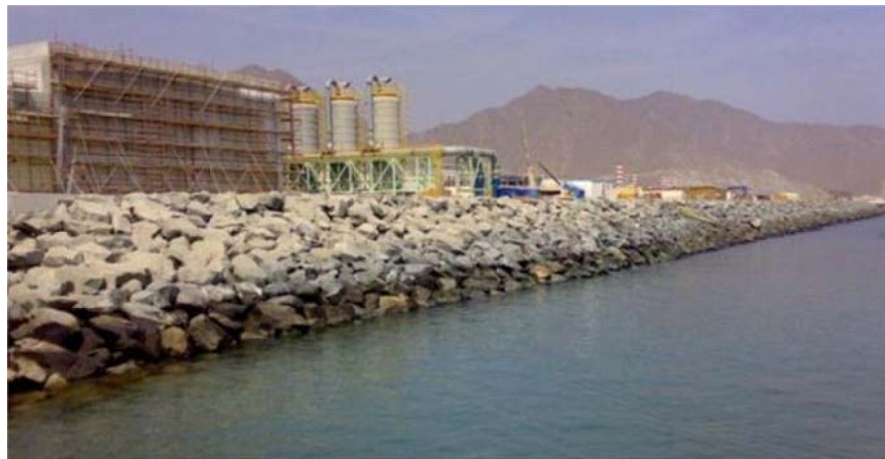
Fig. 4 shows a view of the existing seawall. A typical section through the existing seawall is shown in Fig. 5. The stability analysis showed that the existing seawall is stable for 100 year return period wave conditions but will not resist a storm like Cyclone Gonu. By using Van der Meer stability formulas for shallow water conditions (02004), the damage parameter under Gonou conditions has been assessed.

The result showed that the section would experience intermediate damage during Gonou condition with $T_p=18.6$. But the section would fail during Gonou condition with $T_p=15$ s. The duration of storms were assumed six hours for both Gonou conditions.

The overtopping has been calculated by applying TAW method which also recommended in Eurotop (2007). The TAW method has been combined with the formula of Besley (1999) to obtain wave overtopping behind the crest of the shore protection. The result showed that the seawall would be severely overtopped resulting in damage to the plant.

Fig. 4: Photograph shows the Existing Seawall

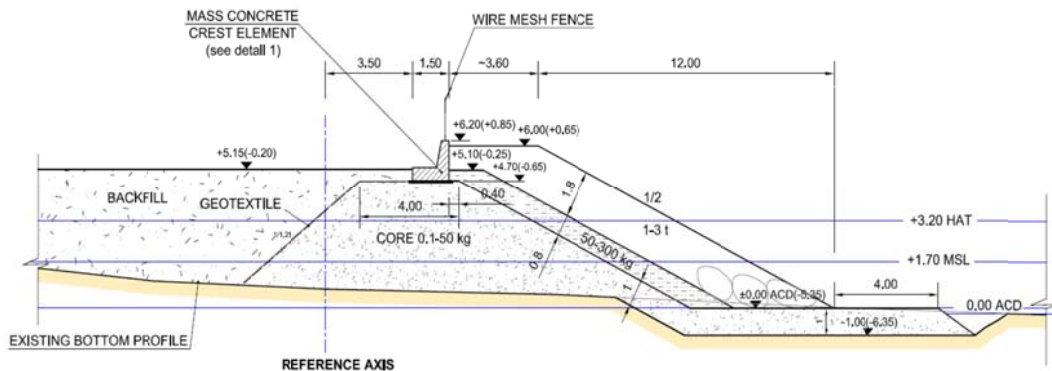
Fig. 5: Typical Section through Existing Seawall

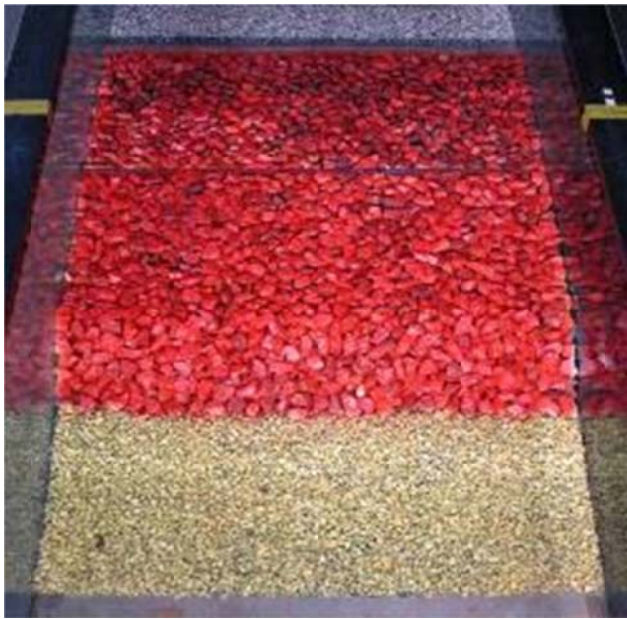
Fig. 15: Photo shows the third proposed section before the tests

The third proposed section is shown in Fig. 15. A splash apron is located above the crest which served as a means of dissipating the remaining wave run-up, splash and spray that could extend above the armor layer. The existing crown wall was protected from both sides by 3-6 ton rocks set at +6.20 m CD. A new crown wall was implemented 20 m behind the existing one. The two crown walls are separated by 3-6 ton rocks.

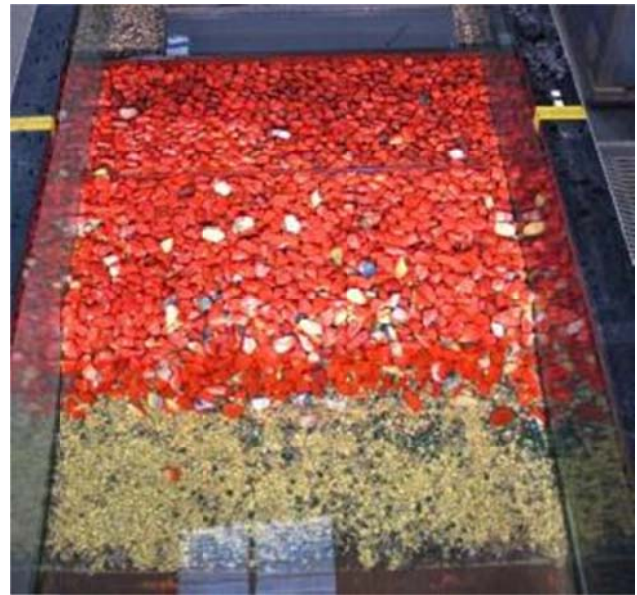
The crown wall was found to be stable under the cyclone Gonu wave conditions. The 3-6 t rocks showed a good stability under cyclone Gonu wave condition. At the end of the cyclone Gonu test ($T_p=18.6$), 3.5% of rocks were displaced. On the other hand, no rock was moved near the new crown wall. Six rocks were pushed over the existing crown wall position. Slight movements were observed under the cyclone Gonu wave conditions. These movements did not destabilize the structure (Fig. 16).

Fig. 16: Photo shows the third proposed section after the cyclone Gonu wave condition ($T_p=18.6s$)

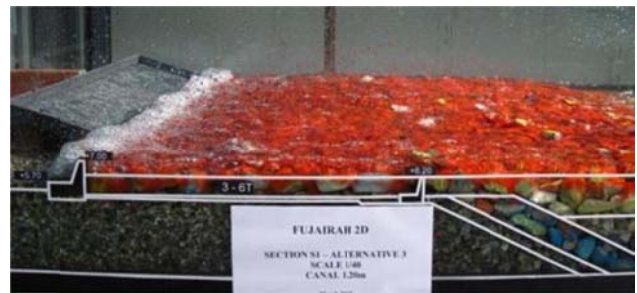
For the cyclone Gonu wave condition ($T_p=15$), only some drops were measured since two waves were just lapping at the new crown wall blocks without passing over the crown walls. For the second cyclone Gonu wave condition ($T_p=18.6$ s), the overtopping was about 0.14 l/s/m. Fig. 17 shows a snapshot of the third proposed section during the Cyclone Gonu test.

Fig. 17: Photo shows the third proposed section during the cyclone Gonu wave condition ($T_p=18.6s$)
